Uniform Mitigation Verification Inspection Form

Inspection Date:		
Owner Information		
Owner Name: <u>BROADWAY PROMENADE CAI</u>	Contact Person: <u>BONNIE NIEDEMAN</u>	
Address: <u>1064 N. TAMiami TRAIL</u>	Home Phone:	
City: <u>SARASOTA</u>	Zip: <u>FL 34236</u>	Work Phone:
County: <u>SARASOTA</u>	Cell Phone: <u>941-951-0260</u>	
Insurance Company: <u>CITIZENS PROPERTY INSURANCE</u>	Policy #: <u>1455953</u>	
Year of Home: <u>2007</u>	# of Stories: <u>6</u>	Email: <u>bniedeman@broadwaypromenade.net</u>

Qualified Inspector Name: JONATHAN KEITH GIPE	License Type: BUILDING INSP. BN	License # or MSFH certificate #: BN6075
Inspection Company: DELTA ENGINEERING & INSPECTION, INC		Phone: (941) 727-2600

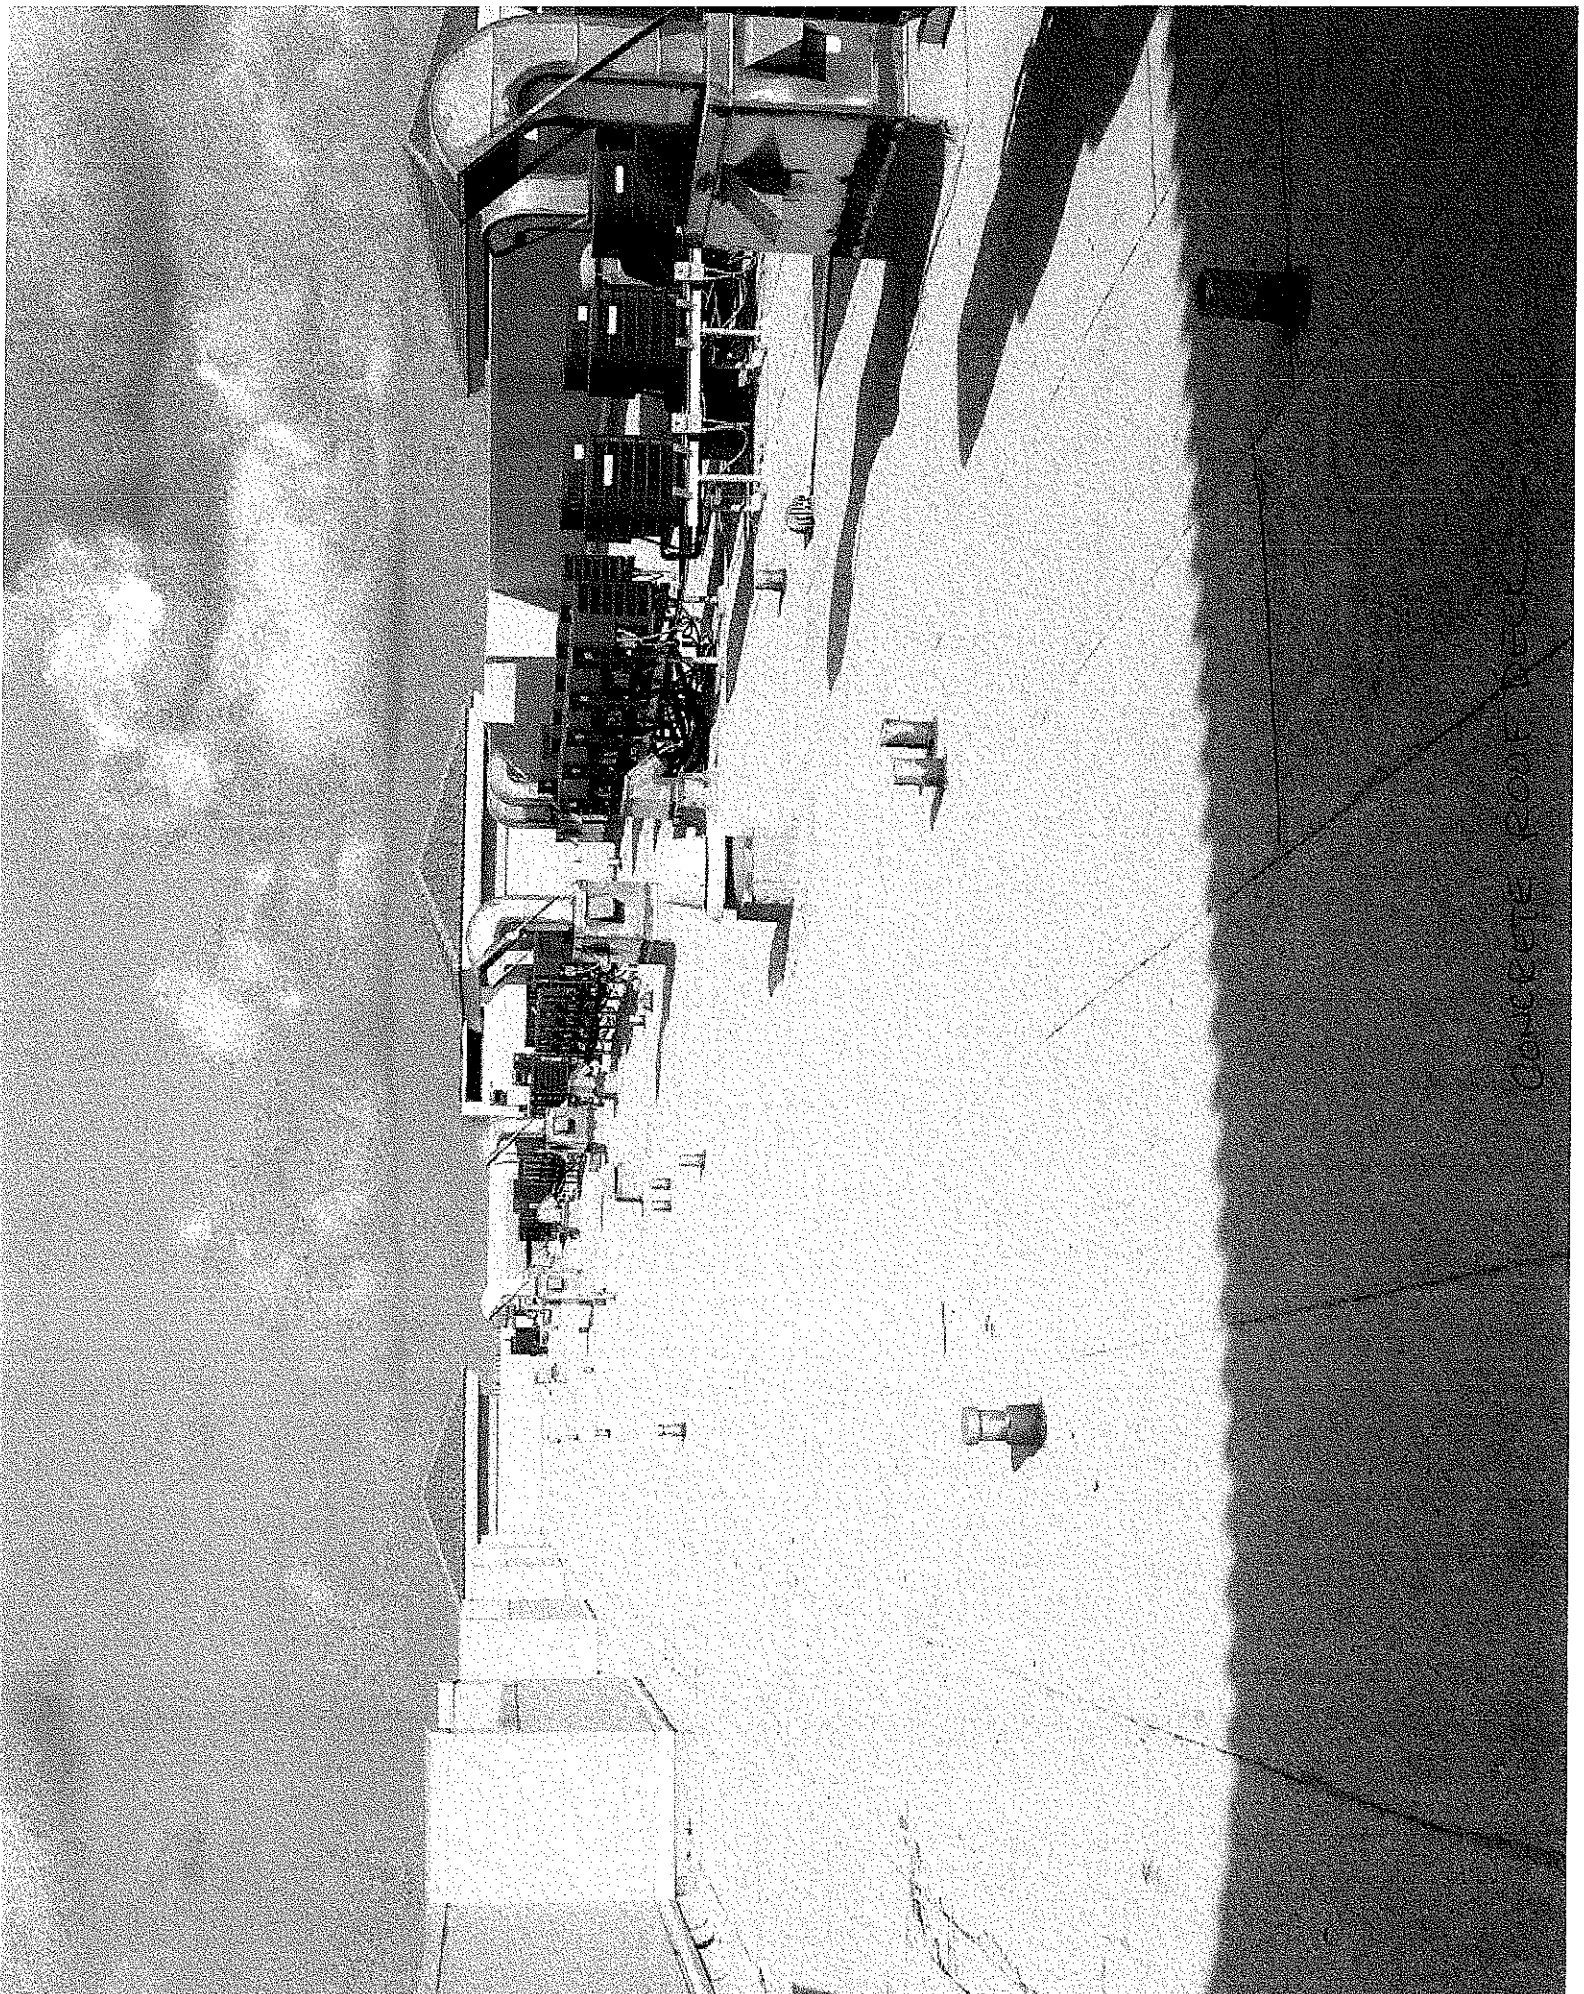
CONCRETE ROOF DECK
